MECHANISM OF DAMAGE TO SHIWEI BRIDGE CAUSED BY 1999 CHI-CHI EARTHQUAKE

An Extensive field investigation was conducted on the Shiwei Bridge in Taiwan damaged by the 1999 Chi-Chi Earthquake and its failure mechanism was inferred. No piers of the bridge showed a displacement in the horizontal direction, but their foundations were found to have been rotated. It is probable that the girders fell off the piers because the length between the piers became enlarged due to the rotation of their foundations or the girders exhibited rotational behavior due to seismic motion in the direction perpendicular to the bridge axis.

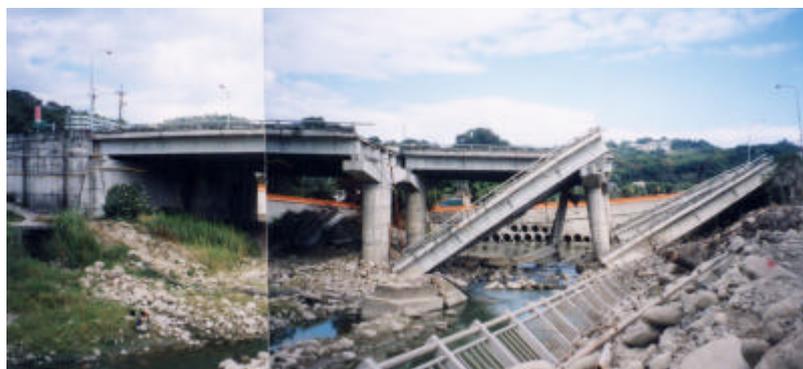
Fig.4 Damage to Shi-Wei bridge

A significant slope failure was observed on the river bank of the abutment A2 side, as seen from Figure 4. One report says that the slope failure may have been caused by the movement of the Chelungpu fault.¹⁾

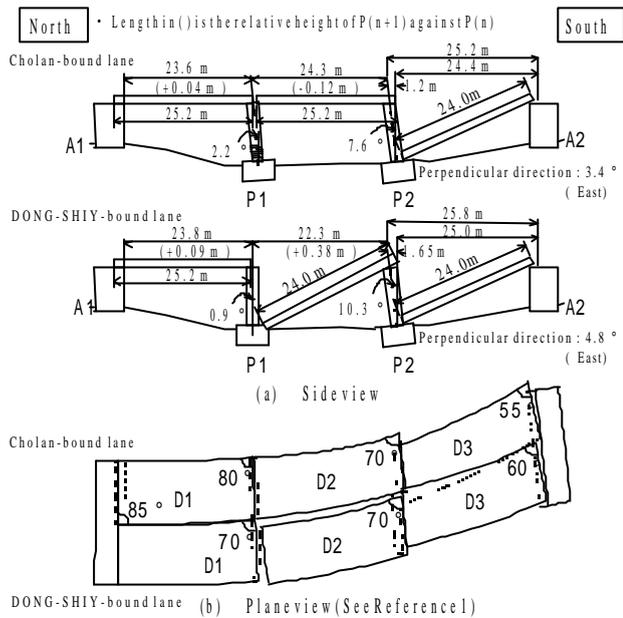
Fig. 3 DamagetoShi-Weibrigdeandmeasurements

The damage suffered by the Shiwei Bridge is shown in Figures 3 and 4. On the Dongshyh-bound lanes, the north ends of the girders D2 and D3 fell from the piers P1 and P2, respectively.

Similarly, on the Cholan-bound lanes, the north end of the girder D3 fell off the pier P2. On both lanes, the girders clashed to the parapets at the abutments A2, the rubber bearings dropped from each bridge seat, and shear keys damaged, as seen from Figure 5.

Figure 3 shows both the length between substructures and the length of girders, all obtained

by our measurements. According to the measurement results, the length between P2 and A2 which jointly supported the girder D3, was 25 m for the Dongshyh-bound lanes and 24.4 m for the Cholhan-bound lanes. It is obvious that the girders fell because the girder length on both lanes, 24 m each, was shorter than the length between the substructures supporting it. In contrast, the girder D2 on the Dongshyh-bound lanes dropped despite the fact that the length of the girder, 24 m, was longer than the length between piers P1 and P2 which was 22.3 m.

The falling of the girders D3 on both bound lanes is presumed to have been caused primarily by the significant displacement of the piers P2 toward the north triggered by the rotation of their foundations as a result of the ground deformation occurred. The occurrence of the ground deformation is verified by the slope failure observed on the river bank. The above assumption is substantiated by the fact that when the length between P2 and A2 before the earthquake, namely 24 m, is added to each horizontal displacement at the top of P2 piers, which is 1.64 m (rotation angle: 10.3°) for the Dongshyh-bound lanes and 1.2 m (rotation angle: 7.6°) for the Cholhan-bound lanes, the derived length on each lane nearly equals to the length between P2 and A2 obtained by our measurements after the earthquake, which is 25.8 m for

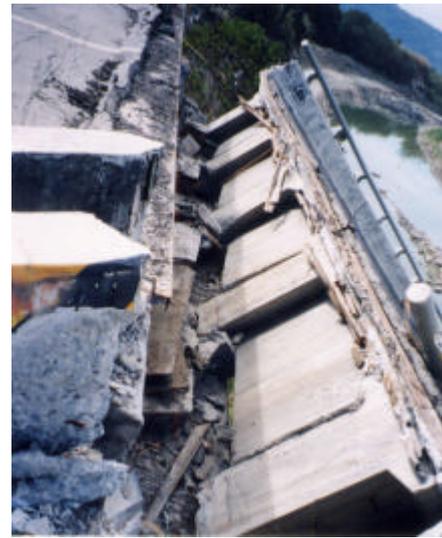
Fig. 5 DamagetoashoenearabutmentA2

As indicated in Figure 3, the Shiwei Bridge is a skew bridge with oblique angles varying from 55° to 85° . As there was a trace that the bridge was also subjected to seismic motion in the east-west direction (direction perpendicular to the bridge axis), as seen from Figure 5, verification was conducted as to the possibility that the girder D2 on the Dongshyh bound lanes had received seismic motion in the perpendicular direction,

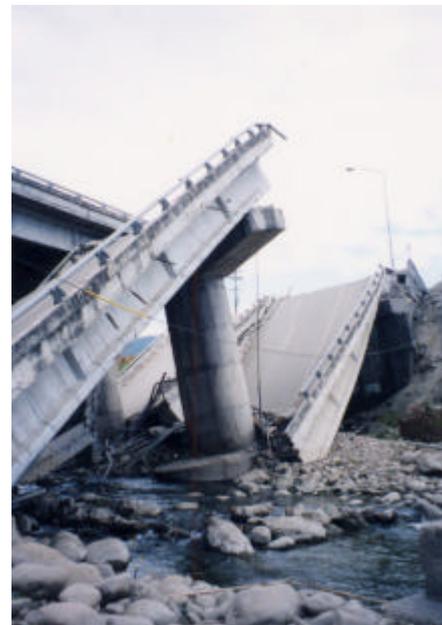
Fig. 6 Tilting of Pier P2 towards the bridge axis direction on the Dong-Shyhboundlane

No serious damage was observed on the pier P1 on the Dongshyh-bound lanes, though it is slightly (about 0.9°) tilted toward the abutment A1. The pier P2 also showed no serious damage to the column itself, but its foundation underwent a significant rotation, as shown in Figures 6 and 7. It tilted 10.3° toward the P1 side and 4.8° toward the direction perpendicular to the bridge axis.

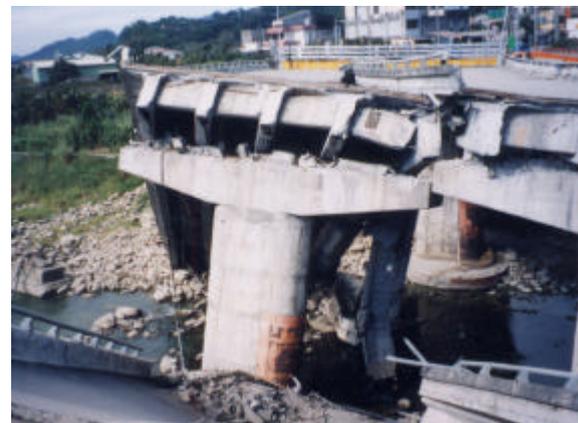
Fig. 7 Tilting of Pier P2 towards the perpendicular direction on the Dong-Shyhboundrane

The pier P1 on the Dongshyh bound lanes showed virtually no residual displacement, but P2 on the same lanes was inclined 4.8° to the direction perpendicular to the bridge axis and 75 cm toward the east direction by the displacement at the top of the pier. It is therefore presumed that the pier was subjected to forces acting in both directions, but it tilted toward the direction easy to rotate.

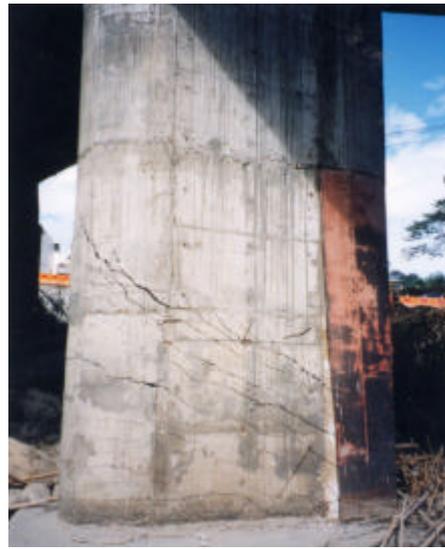
Fig. 8 Damage to Pier P1 on the Cholan-bound lane

With regard to the pier P1 on the Cholan-bound lanes, shear and flexural cracking occurred in the east-west direction at a height about 2 m from the bottom and concrete fell at the bottom of the pier on the north side, as shown in Figure 8. It also tilted about 2.2° toward the abutment A1 side. The pier P2 on the Cholan-bound lanes suffered no serious damage to its column, but again its foundation rotated significantly with a degree of 7.6° toward the P1 side and 3.4° toward the east side. The pier leaned toward the north as a whole.

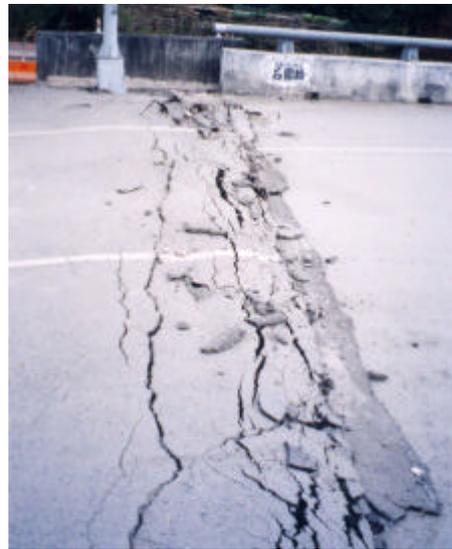
Fig. 9 Damage around abutment A1 on the Cholan-bound lane

The drop of the girder D2 on the Dongshyh-bound lanes despite a longer girder length compared with the length between P1 and P2 was probably because inertia force due to seismic motion acted toward the A2 side before the falling of the girder D3 and following that the girder D2 dropped because of the lack of the seating length, as shown in Figure 10. The occurrence of the inertia force is substantiated by the damages observed, such as falling of concrete and flexural and shear cracking at the bottom of the pier P1 on the Cholan-bound lanes, and by a scar of clash seen at the parapets of abutments A1 and A2. The reason why the girder D2 on the Cholan-bound lanes did not fall off the pier was possibly because the arising seismic energy was absorbed by the damage occurred on P1 and a rise of road surface occurred at the abutment A1 due to the 40-cm sink of the girder toward the A1 side, as seen in Figure 9, resulting in a smaller seismic response compared with that on the Dongshyh-bound lanes.

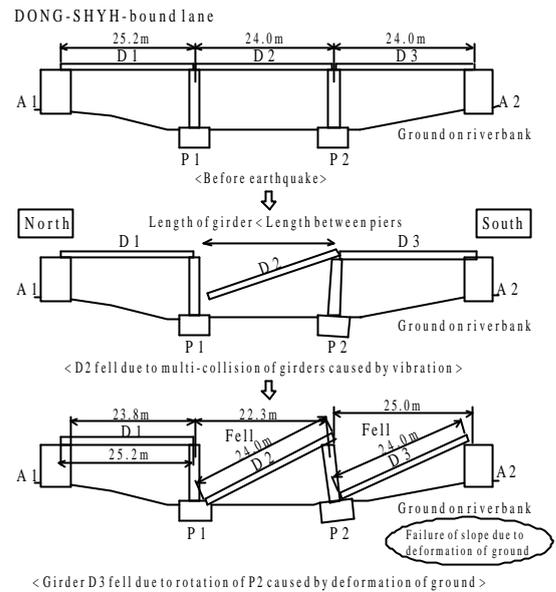
Fig.10 Possible mechanism for fall of girders on the Dong-Shyh-bound lane

As to the girder D2 on the Dongshyh bound lanes, it was inferred that the rotation occurred on the north side of the girder having an oblique angle of 70° , taking Point A at the end of the girder on the obtuse angle side near P2 as its rotation axis, because D2 fell off from the P1 side. Figure 11 is a schematic description of a plan configuration which can undergo rotation geometrically. Figure 12 shows the relationship between the plan configuration ratio (b/L) and the oblique angle () of a skew bridge which can rotate. The area surrounded by slash which

(4) It is considered that if the superstructure had been constructed of a continuous girder, the drop of the girders would have been prevented.
