MECHANISM OF DAMAGE TO SHIWEI BRIDGE CAUSED BY 1999 CHI-CHI EARTHQUAKE

An Extensive field investigation was conducted on the Shiwei Bridge in Taiwan damaged by the 1999 Chi-Chi Earthquake and its failure mechanism was inferred. No piers of the bridge showed a displacement in the horizontal direction, but their foundations were found to have been rotated. It is probable that the girders fell off the piers because the length between the piers became enlarged due to the rotation of their foundations or the girders exhibited rotational behavior due to seismic motion in the direction perpendicular to the bridge axis.

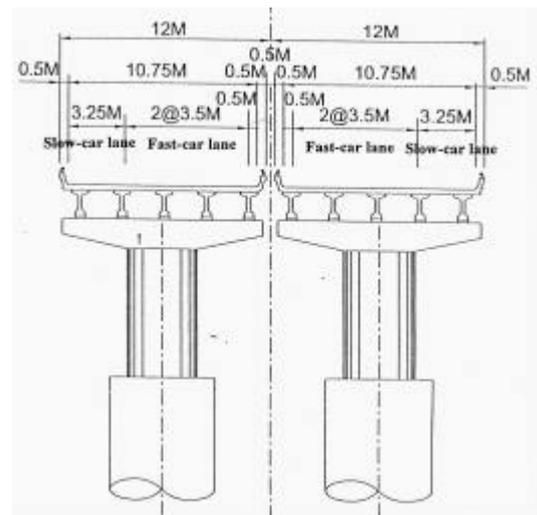
Fig.2 Elevation of Shi-Wei bridge

river (Fig. 1). The bridge, completed in September 1994, is a three-span simple skew bridge with separated north- and south-bound roadways accommodating three lanes each. The superstructure consists of RC-made five girders with a length of 24-25 m and a width of 11.75 m each. The girders are supported by rubber bearings. The bearing conditions were not known from our visual observation. The piers are oval-shaped RC piers with a cross section of 3.9 × 1.5-1.8 m. The height from the pier bottom aboveground to the upper side of the beam is approximately 9 m. The cross sectional view of the Shiwei Bridge is shown in Figure 2. The bridge is a skew bridge with oblique angles from 55 to 85°, as shown in Figure 3.

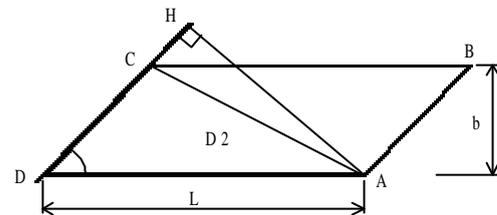
(a) Superstructure with an oblique angle

As to the girder D2 on the Dongshyh bound lanes, it was inferred that the rotation occurred on the north side of the girder having an oblique angle of 70° , taking Point A at the end of the girder on the obtuse angle side near P2 as its rotation axis, because D2 fell off from the P1 side. Figure 11 is a schematic description of a plan configuration which can undergo rotation geometrically. Figure 12 shows the relationship between the plan configuration ratio (b/L) and the oblique angle () of a skew bridge which can rotate. The area surrounded by slash which

Fig. 11 Determination of rotation possibility

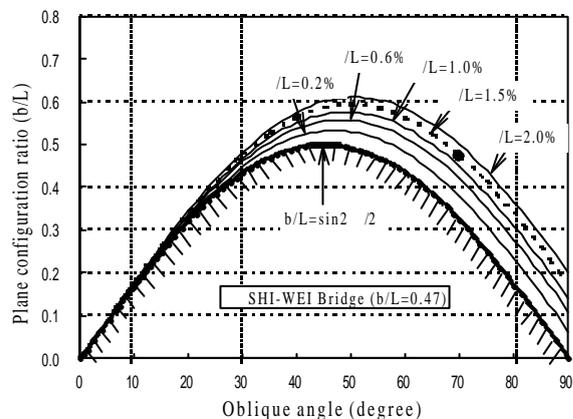
Fig.12 Relationship between an oblique angle (q) and a plan configuration ratio (b/L)

satisfies Equation (1) is the range that can rotate.²⁾ The mark in Figure 12 indicates the relationship of plan configuration ratio ($b/L = 0.47$) and oblique angle ($=70^\circ$) of the girder D2 on the Dongshyh bound lanes. It is seen that the girder D2 is not able to rotate geometrically because the girder is located out of the rotatable area, provided that the positions of the girder and the piers are the same with those before the earthquake.

However, as stated earlier, it is known that the seismic force also acted in the bridge axis direction. If the total of ($= \alpha_1 + \alpha_2$) of joint gaps at both ends of D2 is assumed to have widened by about 35 cm ($\Delta L/L = 1.5\%$) due to seismic forces compared with the gap width before the earthquake, the rotatable area will become the area indicated by a dotted line ($\Delta L/L = 1.5\%$) in Figure 11 from the condition equation (2).²⁾ In this case, the mark showing the girder D2 comes within the rotatable area and hence it can be said rotatable geometrically.
